PROJECT:
HAZARD REPORT, PHASE 2 ELR

APPENDIX B: Conceptual Ground Model (Ch 1100 to 1200)

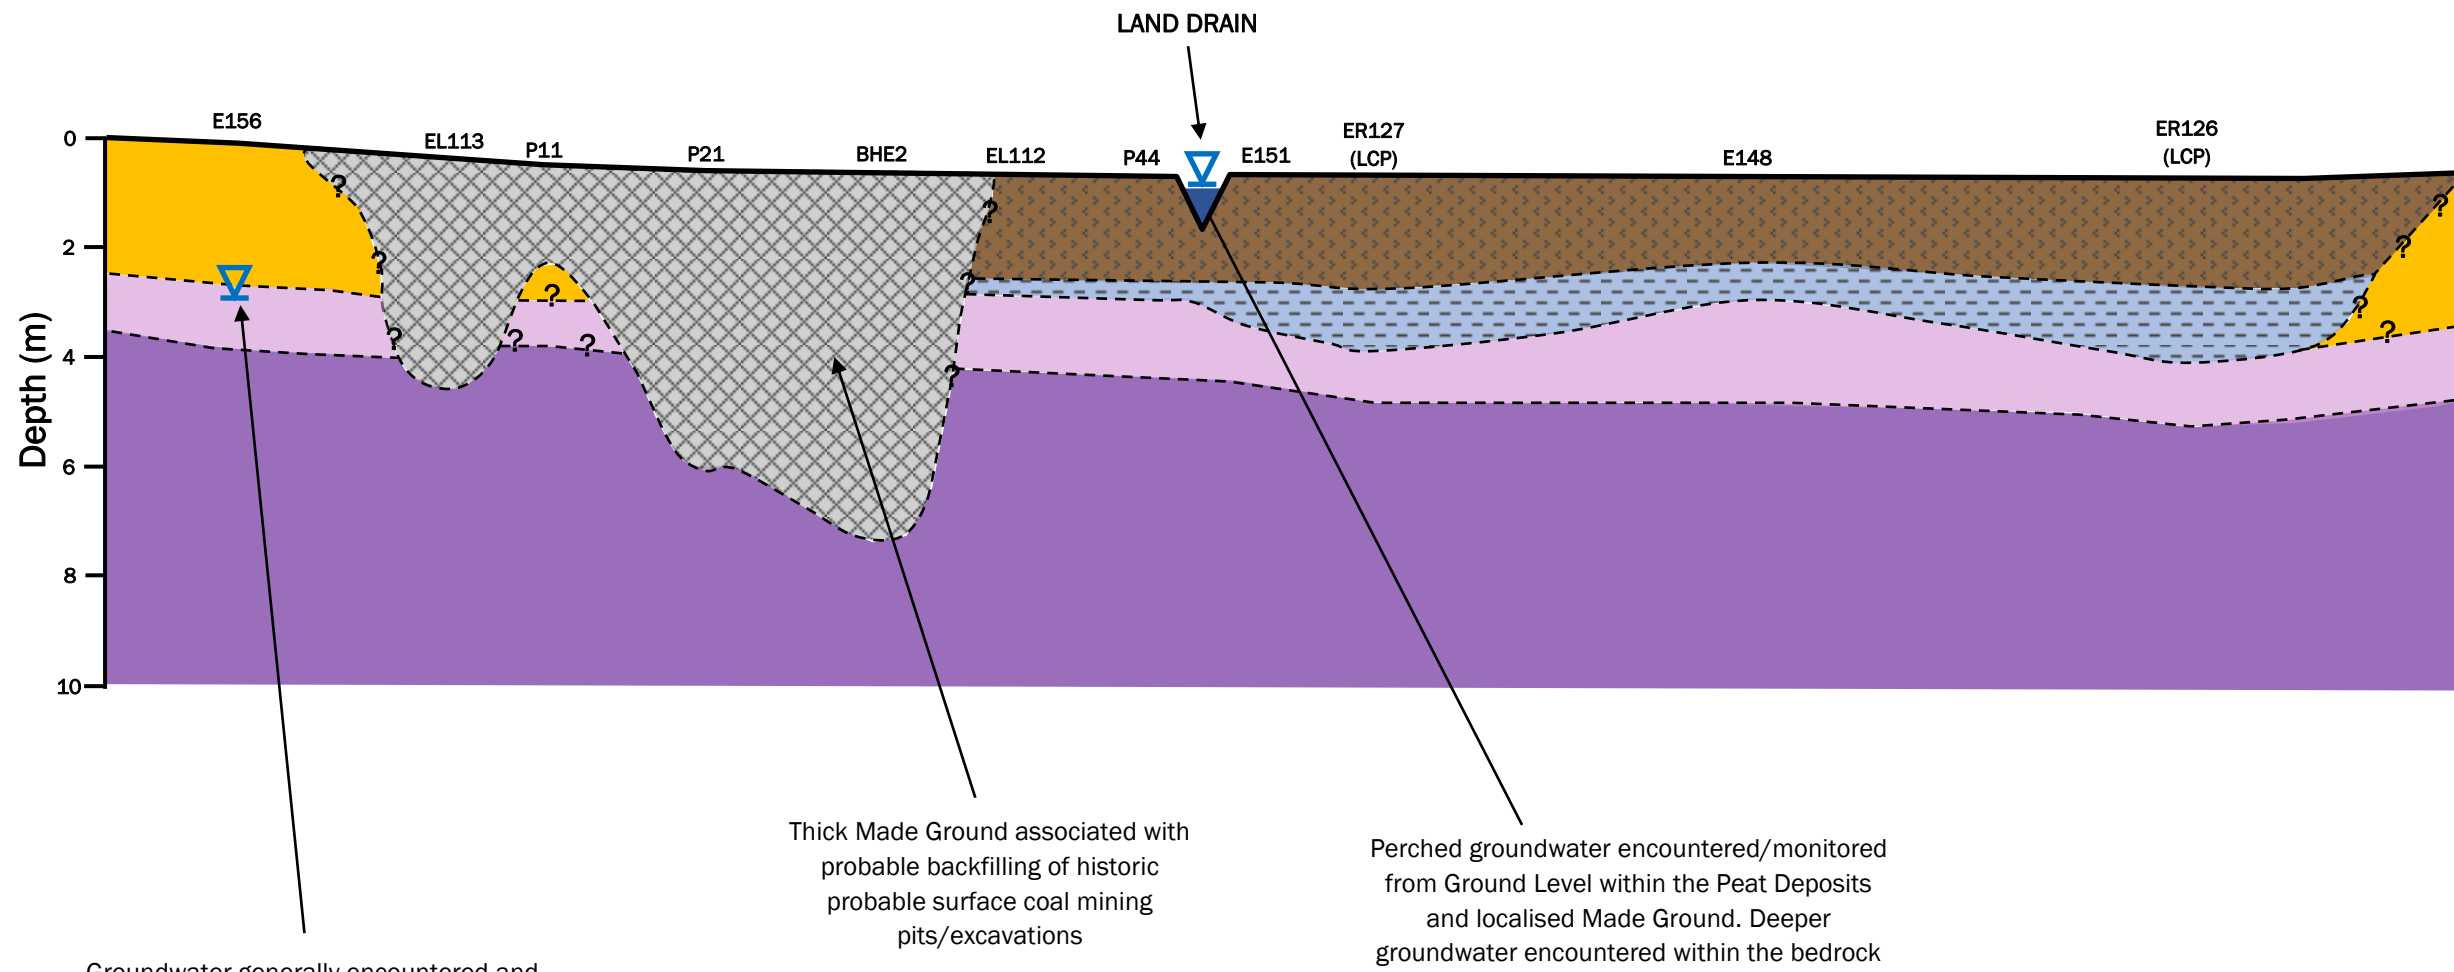
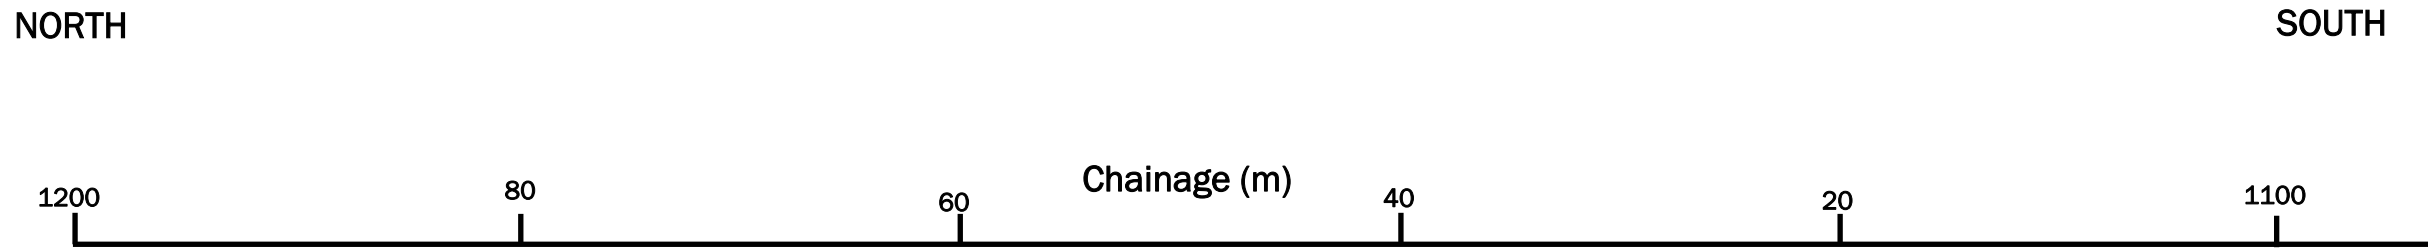
- Notes:**
1. All measurements are approximate with the depths/thicknesses inferred between investigation points to provide an indication of the probable ground model.
 2. The drawing is not at a natural scale.
 3. No details of the bedrock stratigraphy (e.g. Mudstone, Sandstone etc.) or the presence of coal seams is provided.
 4. Detailed information on the ground conditions encountered in each investigation point can be found on the records presented in the GIR (Ref: ESP.6505d.03.2977).
